“And, Where Possible, Materials” — Considering Alternative Materials

By Sharon Ferraro

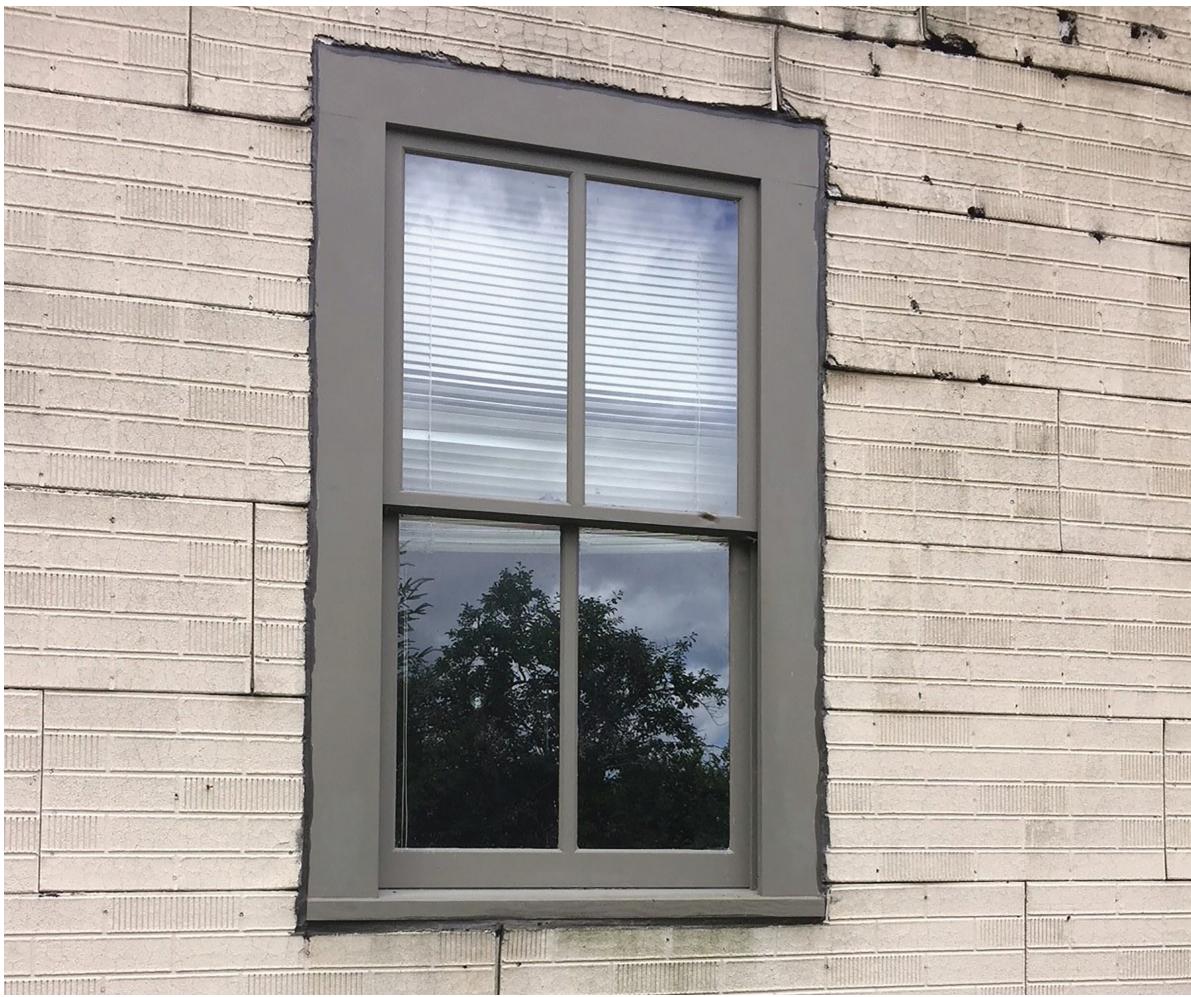
Asphalt/fiberboard siding, trade named Insulbrick, applied in the 1940s to an 1880s miner's cottage.

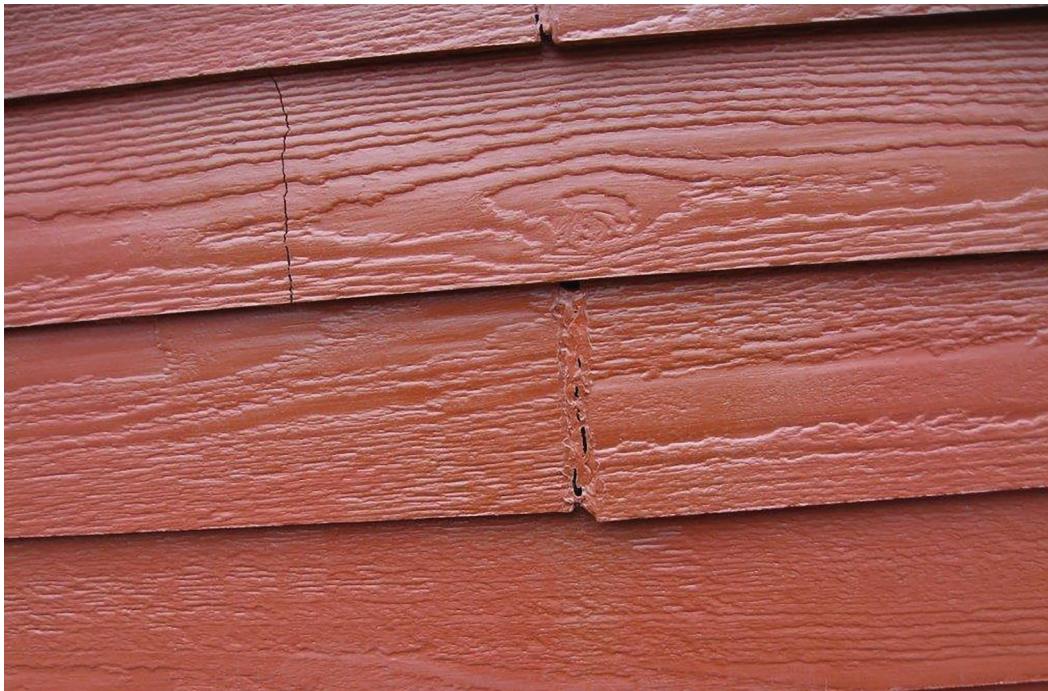
Fiber cement siding (one common trade name is HardiePlank) showing a false wood grain.

There will be cases where the only reasonable alternative is a matching replacement material. Design, dimensions, color and texture should be the closest match possible. While cementitious replacement siding, such as those made by Hardie or Boral have textured material with a deep faux grain, they also make smooth siding that looks very much like new wooden weatherboards. The applicant should supply a sample of the material. Often samples can be obtained from suppliers with a phone call, through the website or at a retail store. If possible, a sample of the authentic historic material may be useful for comparison. Photos are second best for evaluation and should always show the material applied to a building not just a photo of the product.

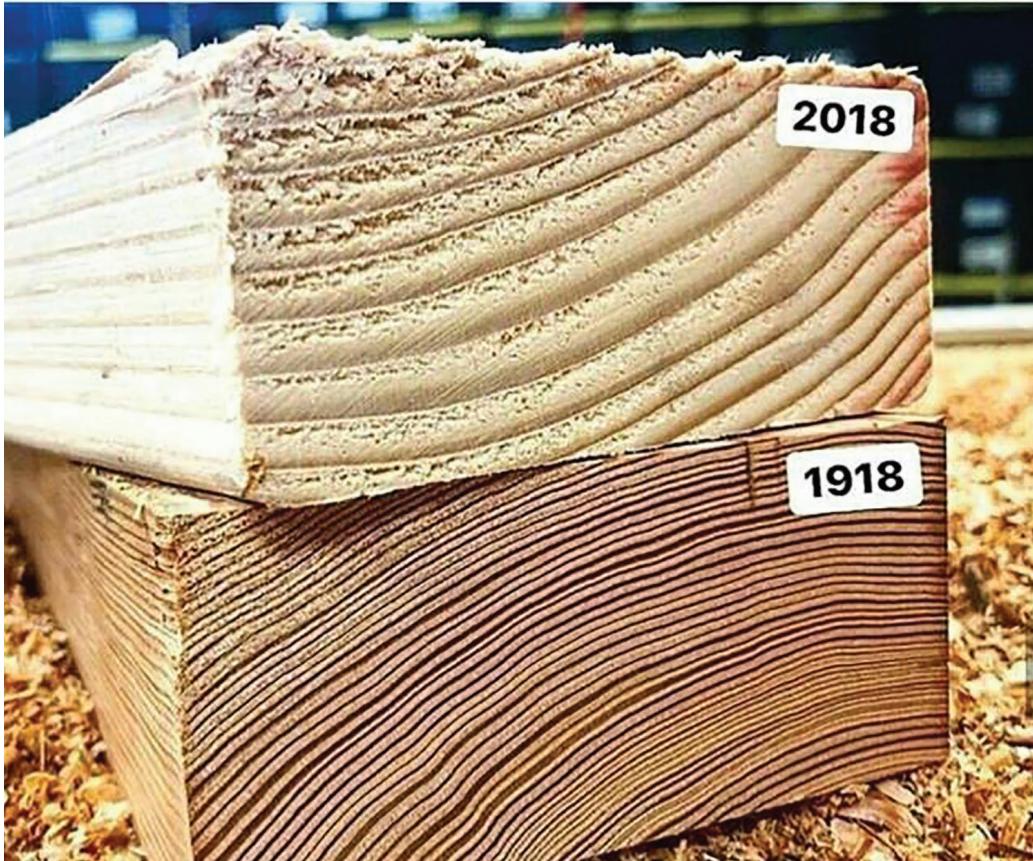
A comparison of new and old growth lumber.

Awesome comparison of an old growth 2x4 vs a new growth 2x4. Notice the old growth has 60 rings and the new growth has 16. The old wood is more dense, stronger, burns slower and is more insect resistant. The new wood was grown for the sole purpose of being used for timber and the old growth was taken from natural forests which we have very few natural forests left.

grain. Modern lumber of the same species is often plantation grown, with optimal spacing for rapid growth and making a wide grain and a weaker, less rot resistant wood. A piece of modern lumber of the same species and with the same dimensions can weigh as much as 25-30% less than a piece of old growth wood. And wood or other material needs to be shaped to match the historic material like replacing a beadboard porch ceiling or turned balusters.

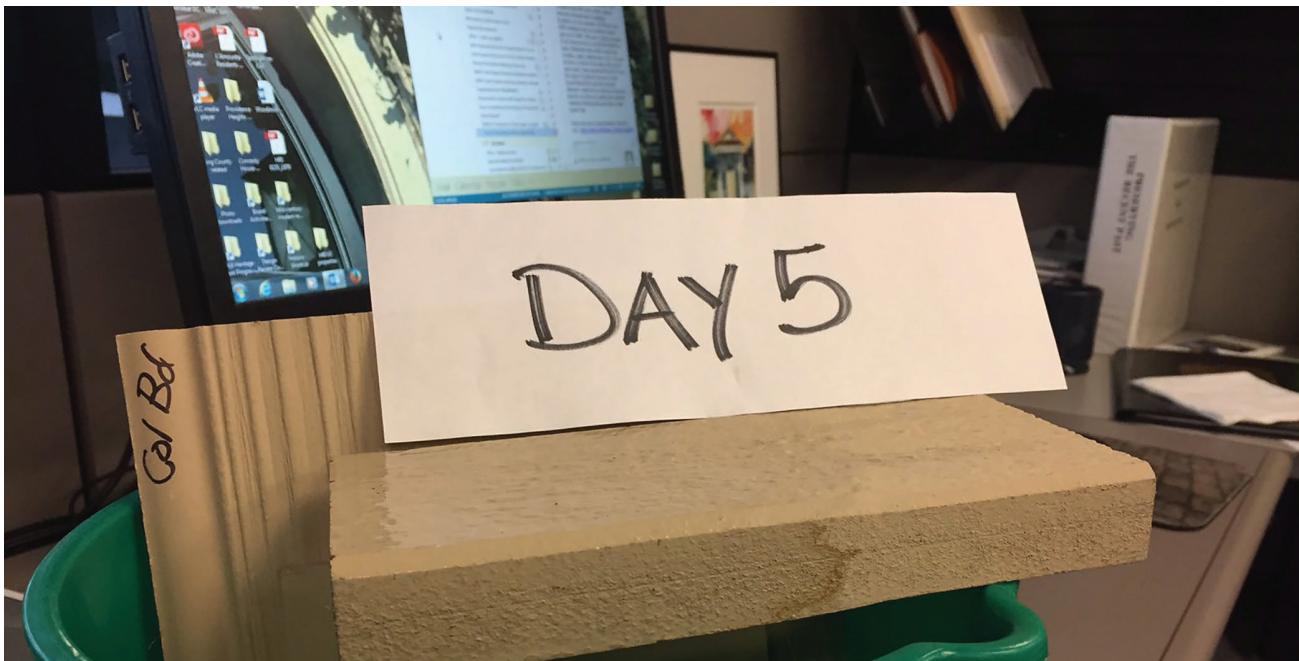
Testing alternative building material's resistance to moisture in the NAPC field office.

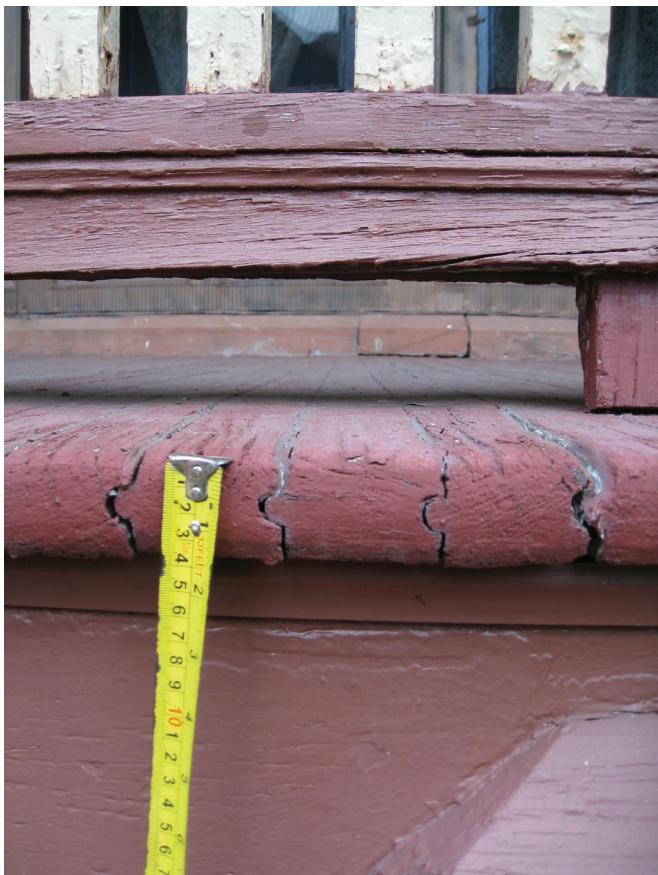
Historic narrow tongue & groove porch flooring.

double the width of the authentic, it cannot be painted, and most all authentic, wooden porch floors were painted, gray, green or red. Painted wooden porch floors never show the grain and all the alternative flooring has a textured wood grain that also hold mold and mildew.

Authentic $3\frac{1}{4}$ " x $\frac{3}{4}$ ", new, old growth, vertical grain, douglas fir porch flooring is available from multiple sources. Salvaged, douglas fir flooring is also available from multiple salvage operations across the country for less money than the new, old growth, douglas fir. This example cuts across every single exterior feature with similar results. That includes porch and staircase balustrades, exterior doors, vinyl or cement board siding, cladding, masonry repair, windows, and most roofs. With a few simple Google searches, authentic materials can be found. Also, in our studies of various communities large and small, there are contractors who can do the work.

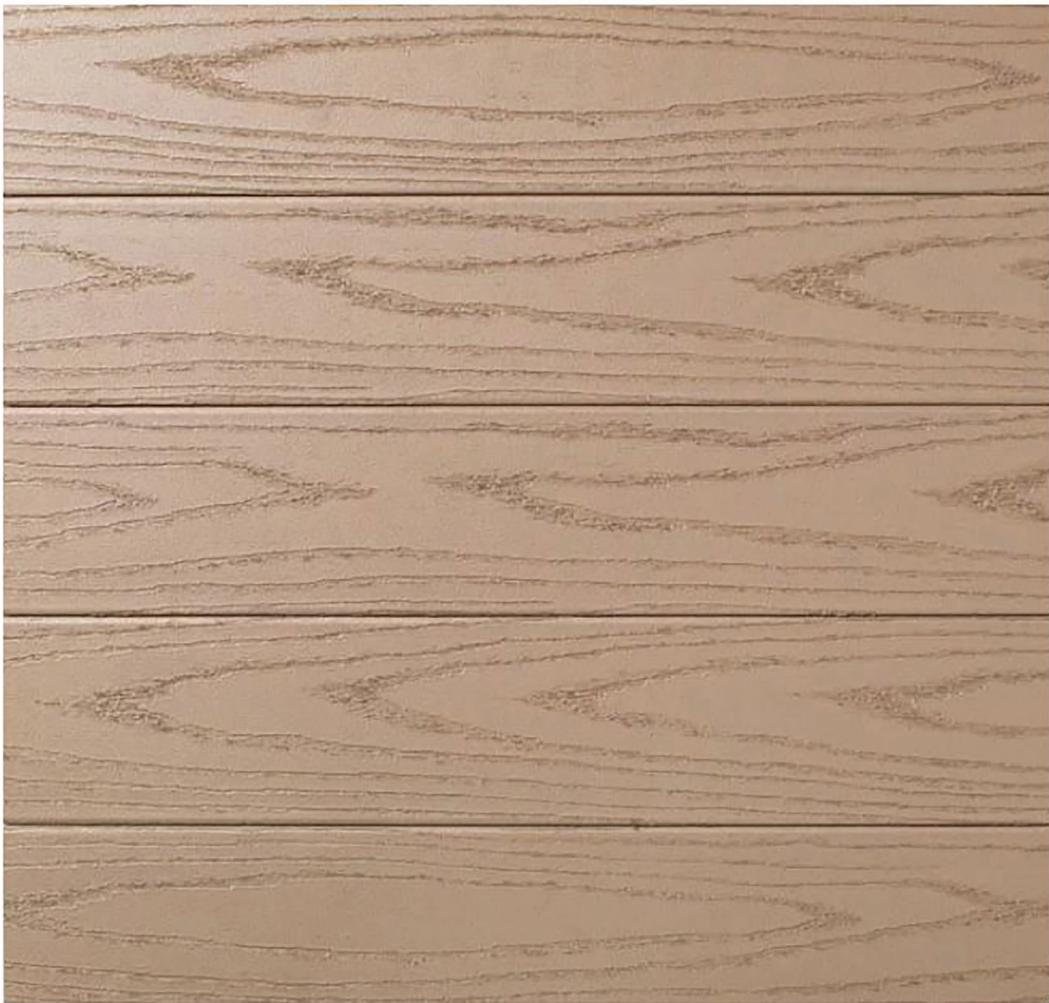
New polymer flooring showing enhanced faux wood grain.
